**Wall heating**

System E-ENERGY CARBON FLEECE

**Renovation of a room in 8010 Graz**

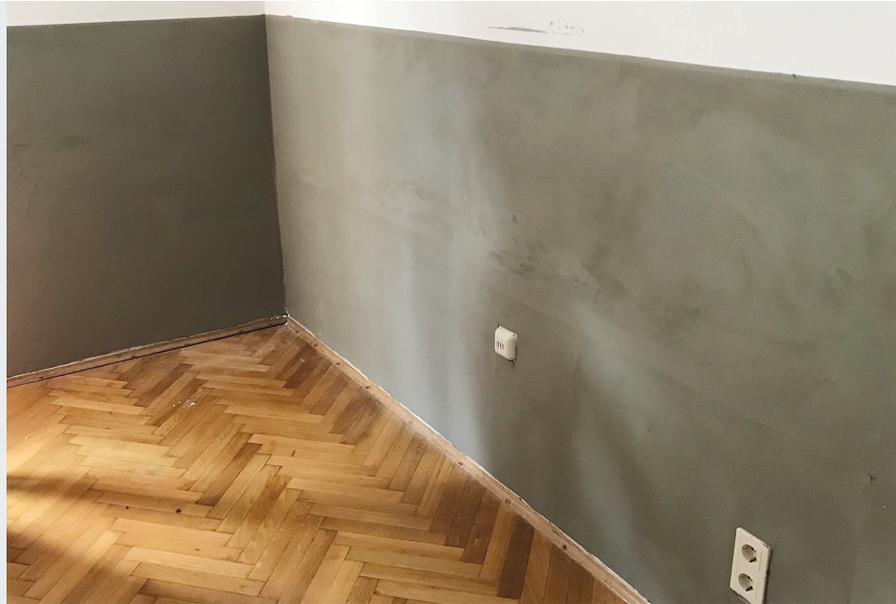
Due to a damp wall with mould infestation, a room in an existing apartment was renovated. To avoid future moisture damage, two heating foils of 5 m length each were installed in the wall of the 30 m<sup>2</sup> room. The E-ENERGY CARBON FLEECE system was used.

Wall covering	Fine putty
Surface heating	E-ENERGY CARBON FLEECE
Surface	30 m <sup>2</sup>
Area	Upper floor

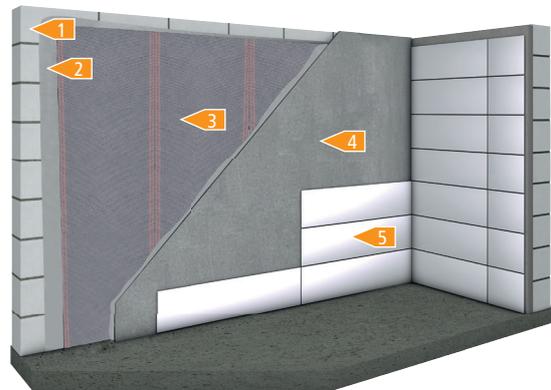
**Construction**

- 1 Raw wall
- 2 Putty
- 3 E-ENERGY CARBON FLEECE
- 4 Fine putty
- 5 Painting, wallpaper, tiles

- 1 mm
- 0,4 mm
- 2 mm
- 4 mm**
